# PBF-LB of Large-Area Magnesium WE43 Structures Surface-Enhanced by Plasma Electrolytic Oxidation

# Ceramic Additively Manufactured Magnesium

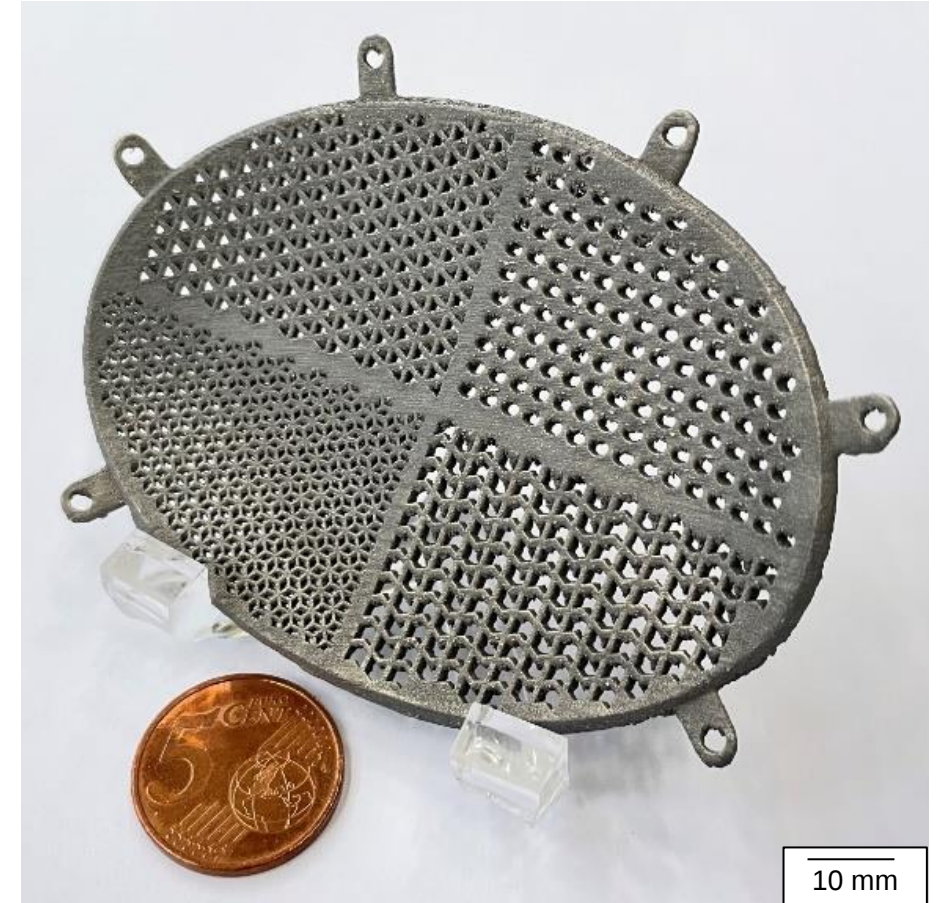
Cranial implant lattice demonstrator

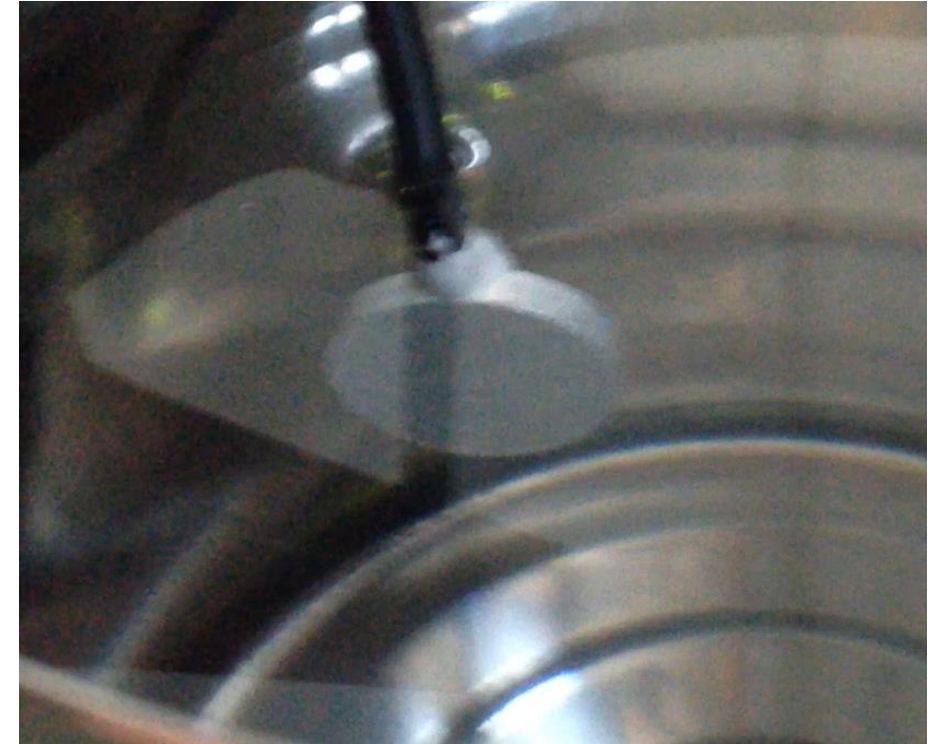
- Plasma Electrolytic Oxidation of cylindrical specimen
  - » Ceramic in solution of electrolytes:
    - Potassium hydroxide (KOH)
    - Sodium metasilicate ( $\text{Na}_2\text{SiO}_3$ )
    - Sodium Diphosphate ( $\text{Na}_4\text{P}_2\text{O}_7$ )
  - » Pulsed energy application to generate plasma
  - » Adjusting voltage, duration, concentration
- Aim of PEO:
  - » Using plasma to melt the magnesium oxide layer
  - » Inclusion of ceramics in the outer layer
  - » Closed surface (layer thickness 10 – 40  $\mu\text{m}$ ) to mitigate further oxidation
  - » General possibilities: thicknesses from 5  $\mu\text{m}$  to 200  $\mu\text{m}$

PEO process video

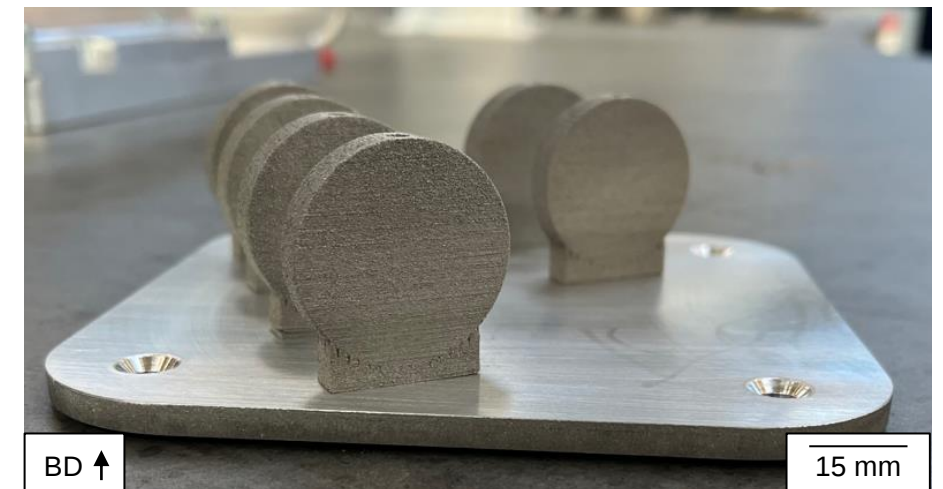
As-built hollow cylinders. Crack-free appearance after PBF

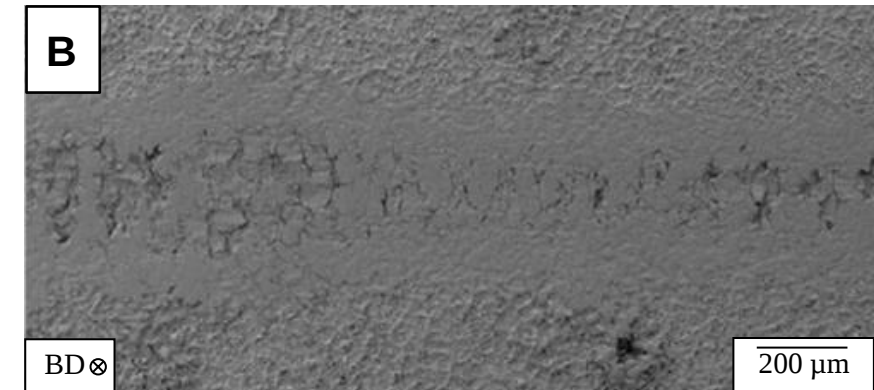
- The thicker ceramic layer leads to a higher COF due to increased surface roughness
- The thinner ceramic layer could not withstand the high load (of 10 N) in testing
- At 5 N load, no wear could be detected for both surfaces
- At 10 N load, (Compared to the native surface) the wear volume was decreased to  $10^{-10}$  %

A: Progression of COF for different load cases on different ceramic surface thicknesses; B: 40 μm Surface after high load testing
